Brown's Gulch
Casagrande Property
plan view

PROJECT NO. 10-04847-000

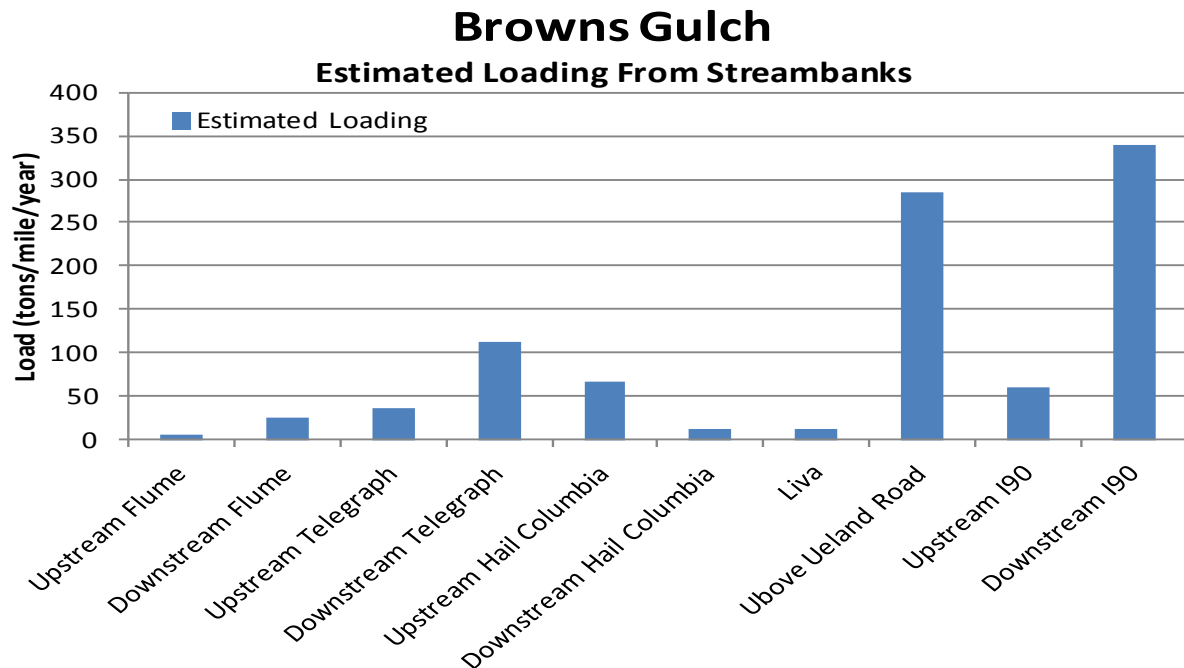
Sediment loading estimated using Rosgen BEHI method in field on ten distinct reaches. Pilot channel & riparian corridor improvement projects in this proposal are on “Downstream Telegraph (Casagrande)” and “Above Ueland Road” reaches, two of three most problematic reaches. These loading rates are very high, indicating the severe issues with bank and channel stability in certain sites. (Analysis by Karin Boyd for Pioneer Technologies, Mile Hi Conservation District/WRC, 2011).

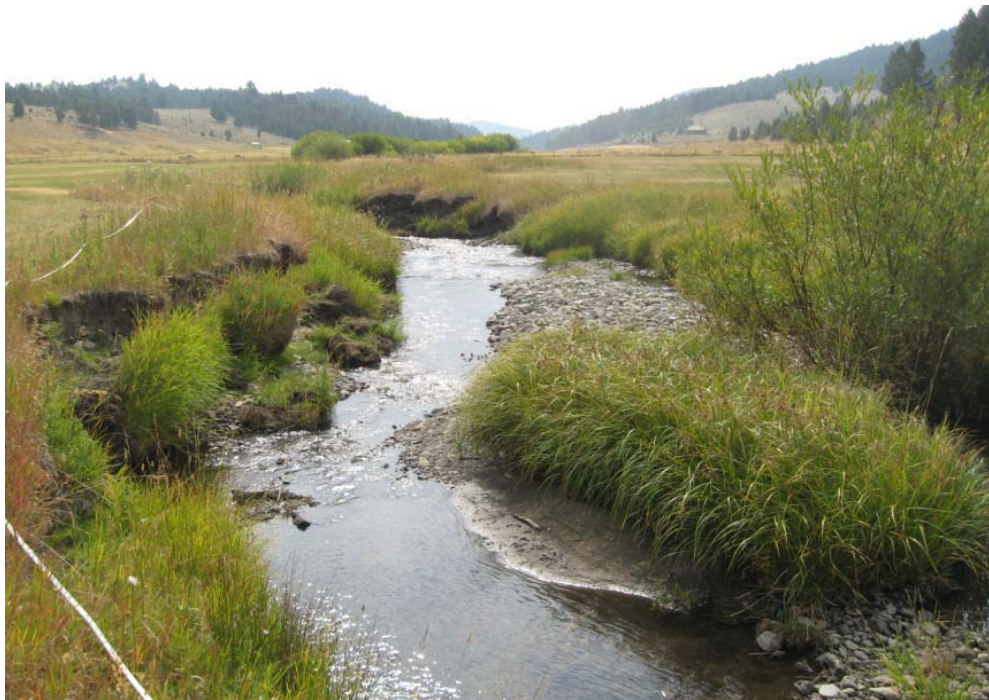
Typical channel conditions on Casagrande property. Note narrow riparian corridor, scarce deep rooted plant cover, high bank erosion.

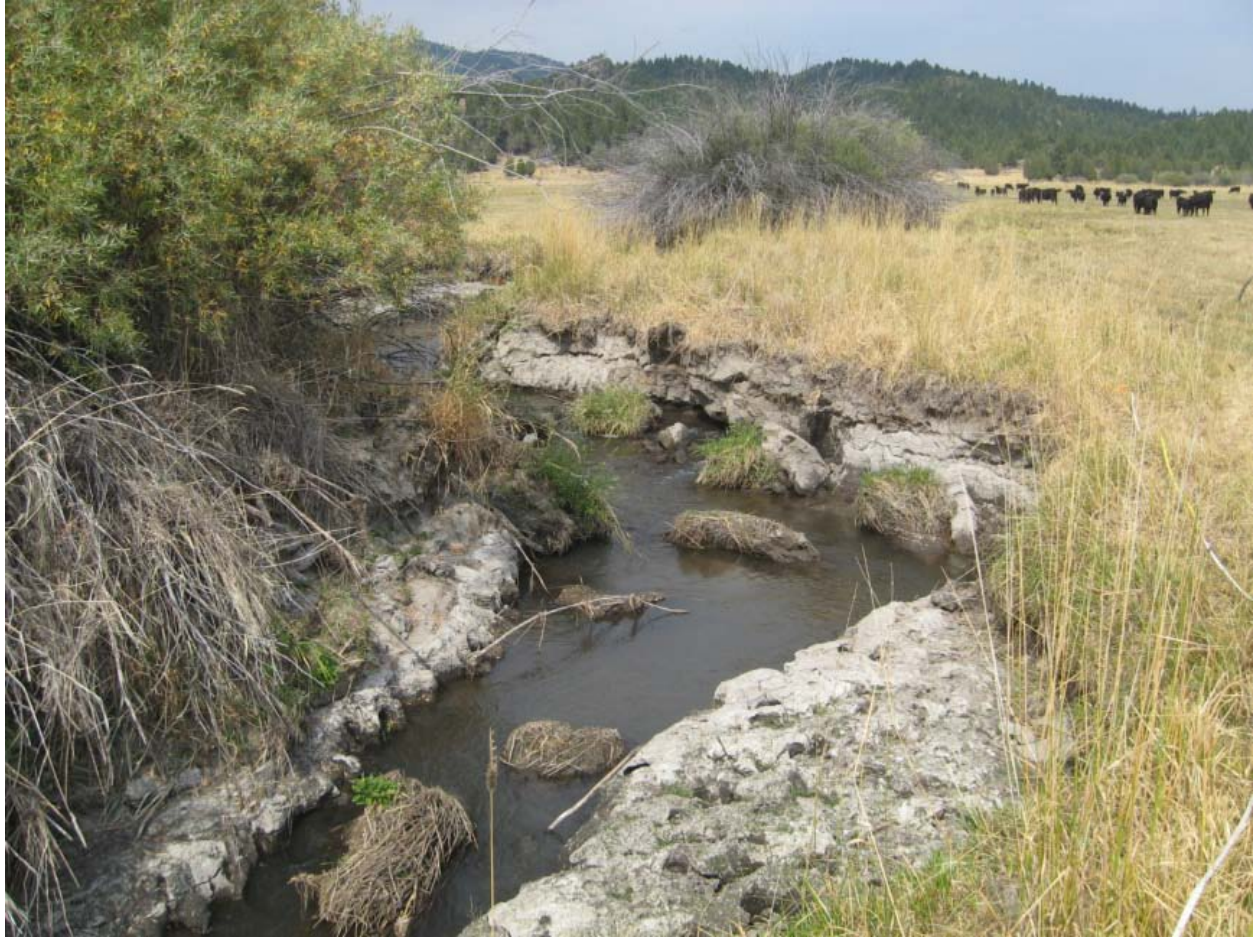
Photo of reach "Above Ueland Road." This is a pilot channel improvement site, which will involve grade control, soil lift bank protection and revegetation with livestock exclosure/water gaps.
